488 New Britain Road

1985 Townwide Historic and Architectural Survey of Berlin, Connecticut. Survey # 122

HISTORIC RESOURCES INVENTORY
BUILDING AND STRUCTURES
HIST-6 NEW 5/77

Willis Upson House

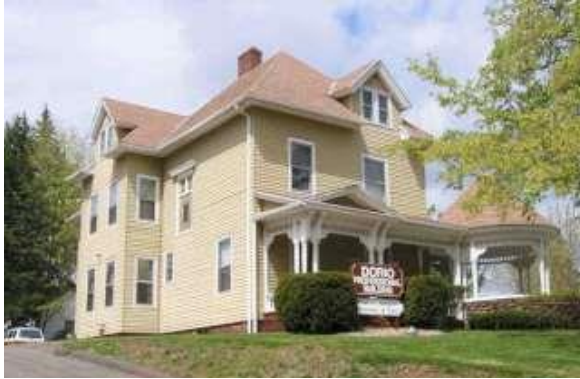
Victorian

The Upson family had fairly extensive holdings in this area of Kensington and operated a grocery store and post office on Four Rod Road (still extant) for several decades. Willis Upson died in 1910. The house is now a senior citizens center.

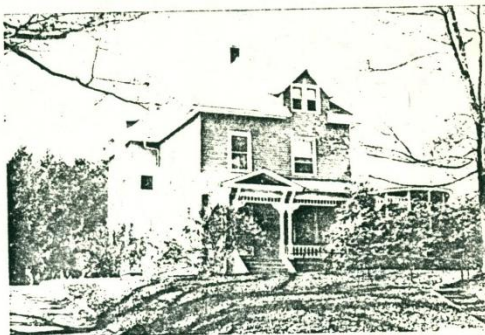
PHOTO COMPILED BY	PHOTOGRAPHER HRC	DATE 11/84
	VIEW NW	NEGATIVE ON FILE A29A
	NAME Historic Resource Consultants	DATE 12/84
	ADDRESS The Colt Armory 55 Van Dyke Avenue Hartford, Connecticut 06108	
20. SUBSEQUENT FIELD EVALUATION:

DESCRIPTION (Continued)	17. OTHER NOTABLE FEATURES OF BUILDING OR SITE (interior and/or exterior)	
	<p>The Willis Upson House is a large house with a roughly cruciform plan. Both the main house and side projections feature hip roofs and small gabled wall dormers; dormers on the front and rear elevations are off-center. The two-bay facade has a left entry; the original entry door has a single large light over panels. A one-story porch with a shallow roof extends across the facade and wraps around to the right ell; a small framed-in extension continues to the rear of the right ell. The porch features turned posts and a stickwork frieze; posts are paired and tripled at the corners. The jigsawn post brackets have roll-molded edges, raised circular bosses, and panels with incised sunburst designs. The turned balusters are topped by a plain rail. There is a pedimented peak centered over the entry, and a (continued)</p>

18. ARCHITECT	BUILDER
SIGNIFICANCE	19. HISTORICAL OR ARCHITECTURAL IMPORTANCE	
	<p>Despite much modern alteration, the Willis Upson House is significant as a good example of Victorian Vernacular architecture. The ornamental woodwork typical of the style is seen in the elaborate detail of the porch, with its turned posts and balusters, carved post brackets, and stickwork frieze. In the middle of the 19th century, advances in mechanized lathes, saws, drills and other basic wood-forming tools made decorative woodwork widely affordable and its use became widespread during the Victorian period, especially as in this house for creating highly decorative porch detail. The applied bosses, carved edge moldings, and incised designs relate the house's woodwork to the Eastlake-style furniture popular in the period.</p> <p>Willis Upson, a grocer, probably built this house about 1895. (continued)</p>	
SOURCES	<p>1880 Census 1900 Census Berlin Land Records 51:557</p>

large round pavillion with a conical roof at the right-front corner of the porch. On all elevations, the bulk of window, wall, and eave detailing is obscured by modern siding and sash; a diamond-pane stair window survives near the front of the left elevation.
